MONUMENT RECORD
State of Indiana - County of Monroe

Corner ID: Polk Q-23

LAND CORNER RECORD
(RECTANGULAR SURVEYS)

Index No. X-17
(Alphabetical - Numerical)LAND CORNER RECORD
(RECTANGULAR SURVEYS)R9-7150-4 (Rev. 6/13/67)
GPO 806-924T. 2N S. 1E Mer. 2nd N.F. No. 3127 County Monroe State Ind.
W Section Corner common to sections 34 35 and _____

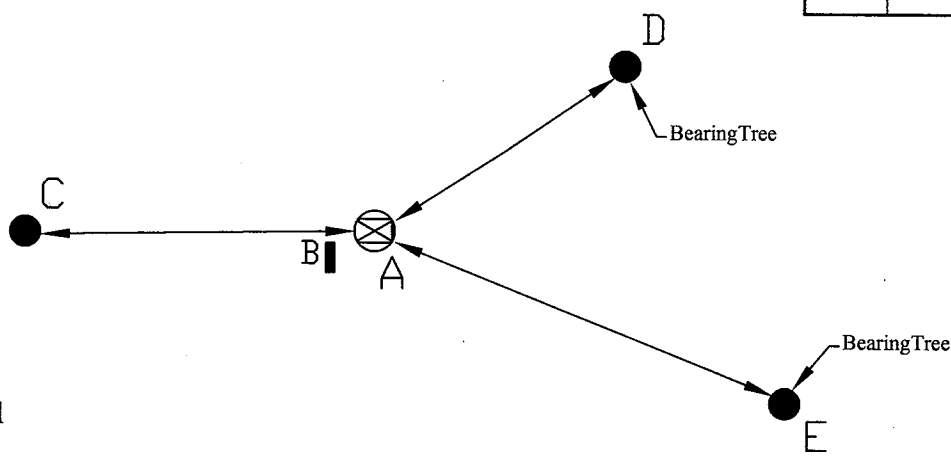
RECOVERY TIE DRAWING
Field Book 33 Page No. 32
Field Book 41 Page No. 69

Monument Description & Remarks: 3" Aluminum cap. Survey Sign 5ft above ground at pt. D

A - 3" Aluminum cap
B - S 86° W 1.90' to metal
fence post
C - S 80° W 16.56' to MAG
in 22" Black Oak
D - N 49° E 12.99' to Bearing
Sign on 22" Pignut Hickory
E - S 53° E 26.04' to Bearing
Sign on 18" Black Oak

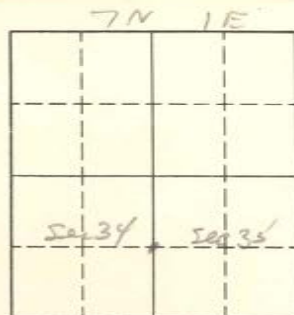
Sketch

Corner monument

T2N R1E Secs 34 & 35

Describe evidence of use and occupation such as roads, fences, clearings, timber cutting lines, plantations, etc.. Cite source of testimony if any. Talked to local residence. They know of no stone ever been in this location. Bob is the owner of the S. Acres in the SE 1/4 NE 1/4 of Sec. 34.

Dutch Ridge
road is 38 rods West of Corner - Did chain from road and found no evidence of corner stone.
